# Conceptual Estimate

## First Presbyterian Church Exterior Envelope Renovation

**May 8, 2025**

**Garbutt Construction**

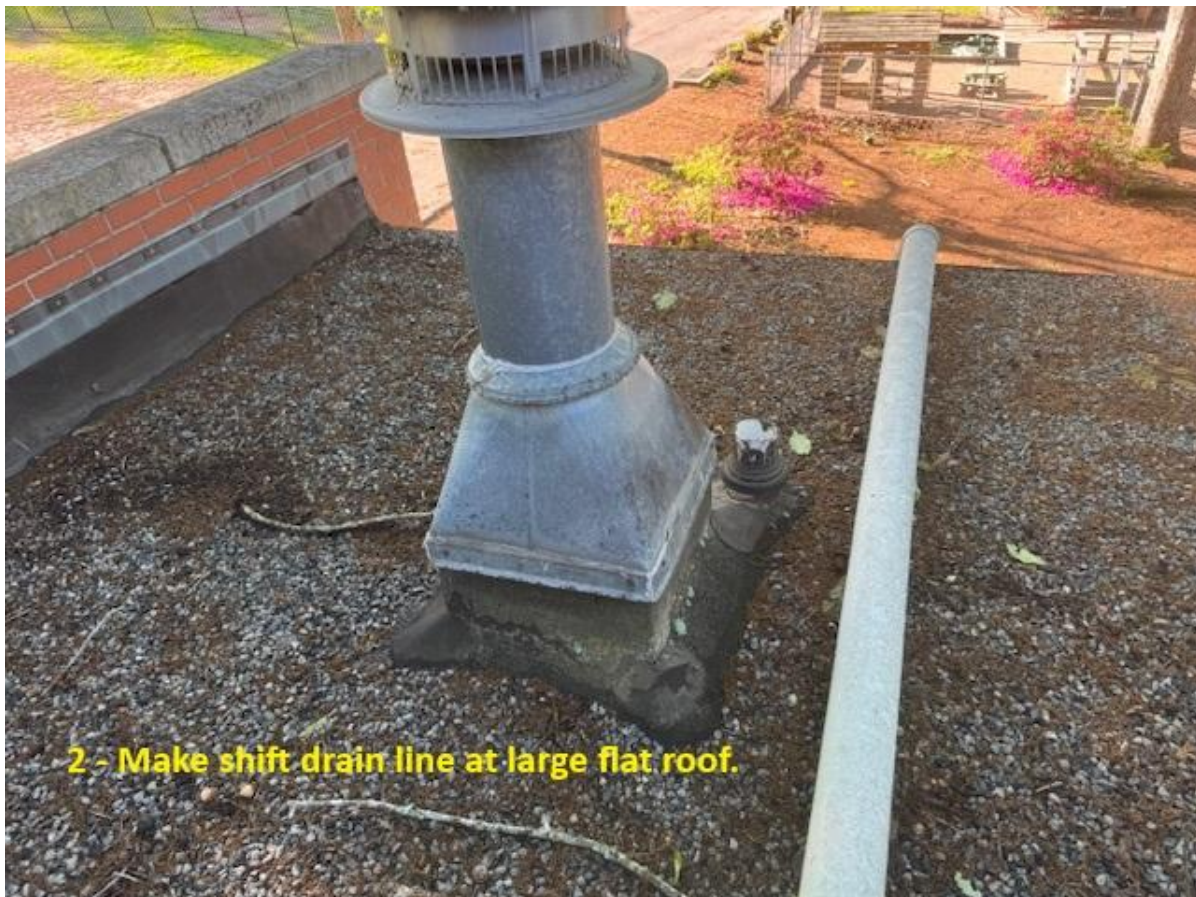
**2 - Make shift drain line at large flat roof.**

- South Side Rear Flat Roof
  - Remove existing gravel roof and substrate insulation.
  - Remove and dispose of plastic drain lines.
    - See photos 2, 16, and 17.

- Fully adhere the new 60mil TPO roof membrane at all required roof penetrations and at roof/wall intersection base flashings.
    - See photos 2 and 18.

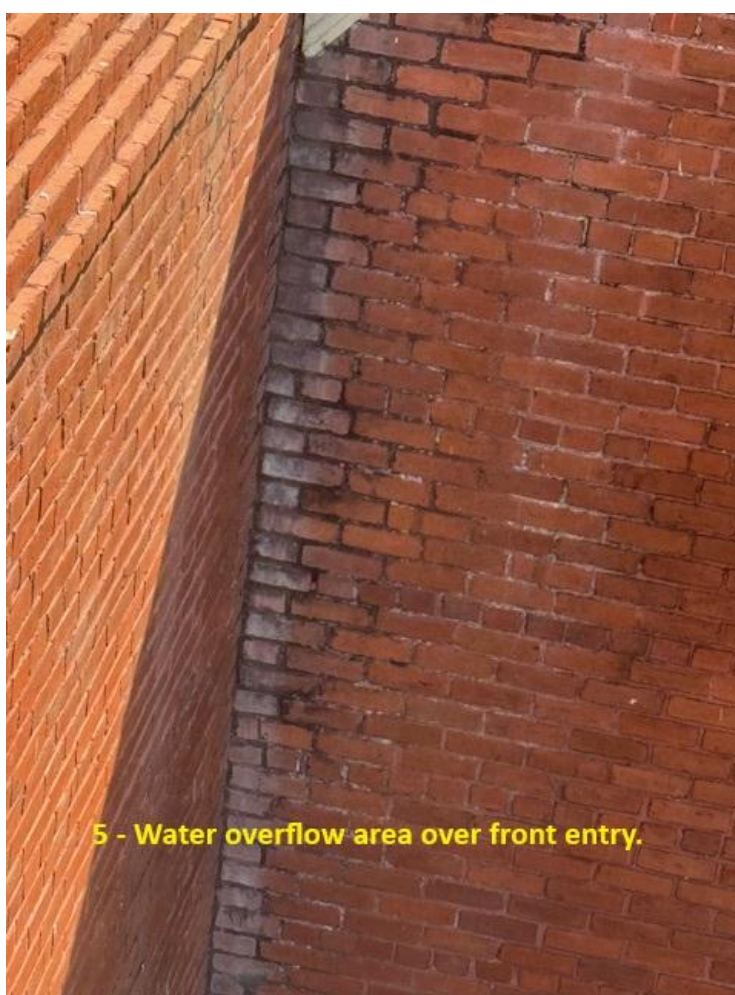
5 - Water overflow area over front entry.

- Foam backer rods will be used, if needed, at certain locations.
  - Pressure wash corner area of wall to remove everescents
    - See photo 5
  - Investigate cause of everescents caused from overflow of water from above and attempt to improve or eliminate this condition.

- See photo 5.
  - Remove and dispose of all debris generated by this scope of work.
- Front Standing Seam Metal Roof
  - Remove gutters, downspout, roof/wall flashings, and counter flashings.

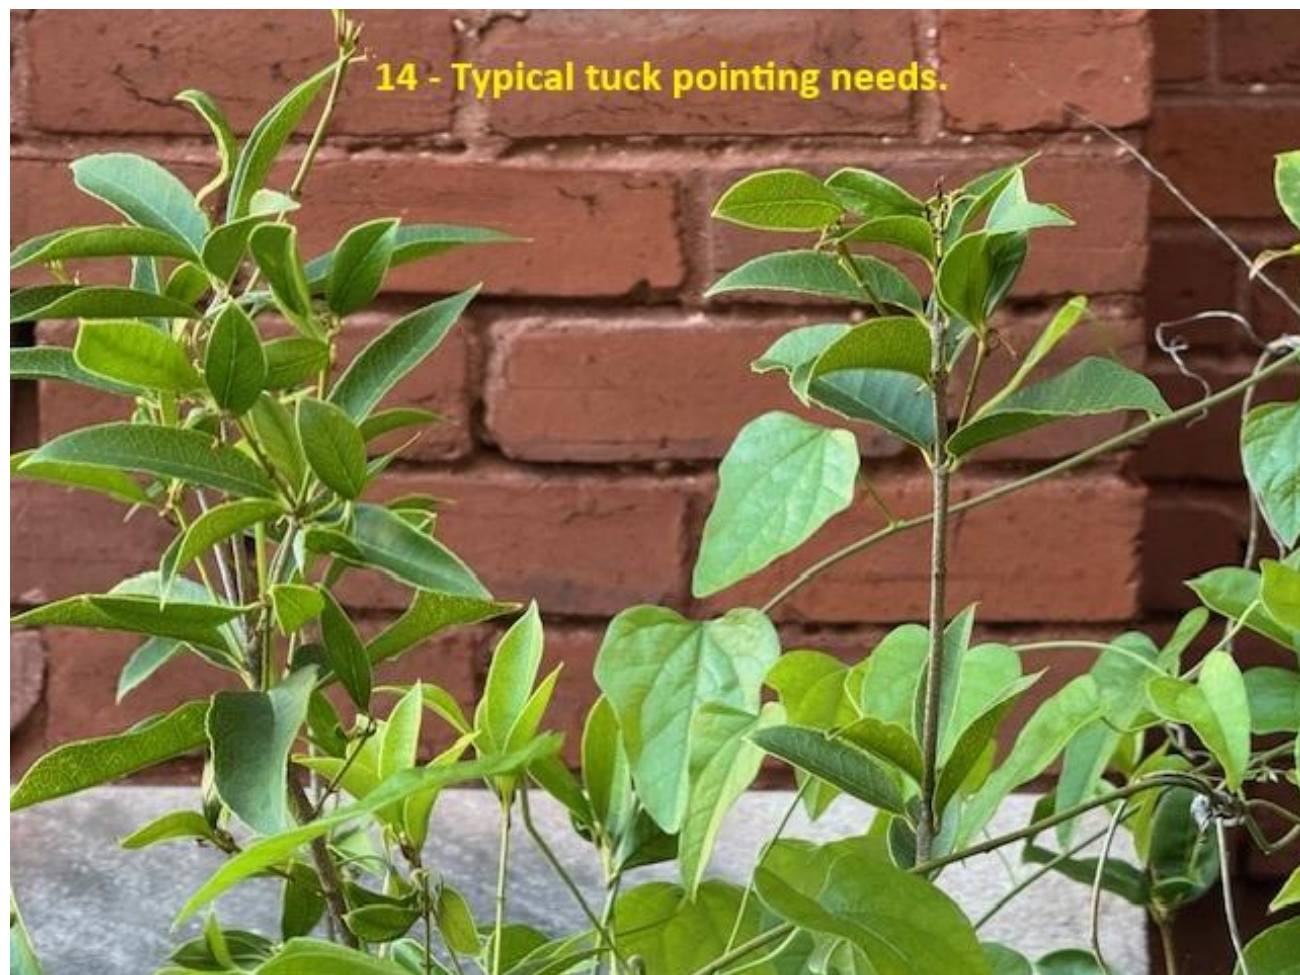
14 - Typical tuck pointing needs.

- Cut and/or grind out mortar joints, as needed, to a depth of 1 — 1 1/2" deep.
  - Apply new masonry cement and match existing mortar color as closely as possible.

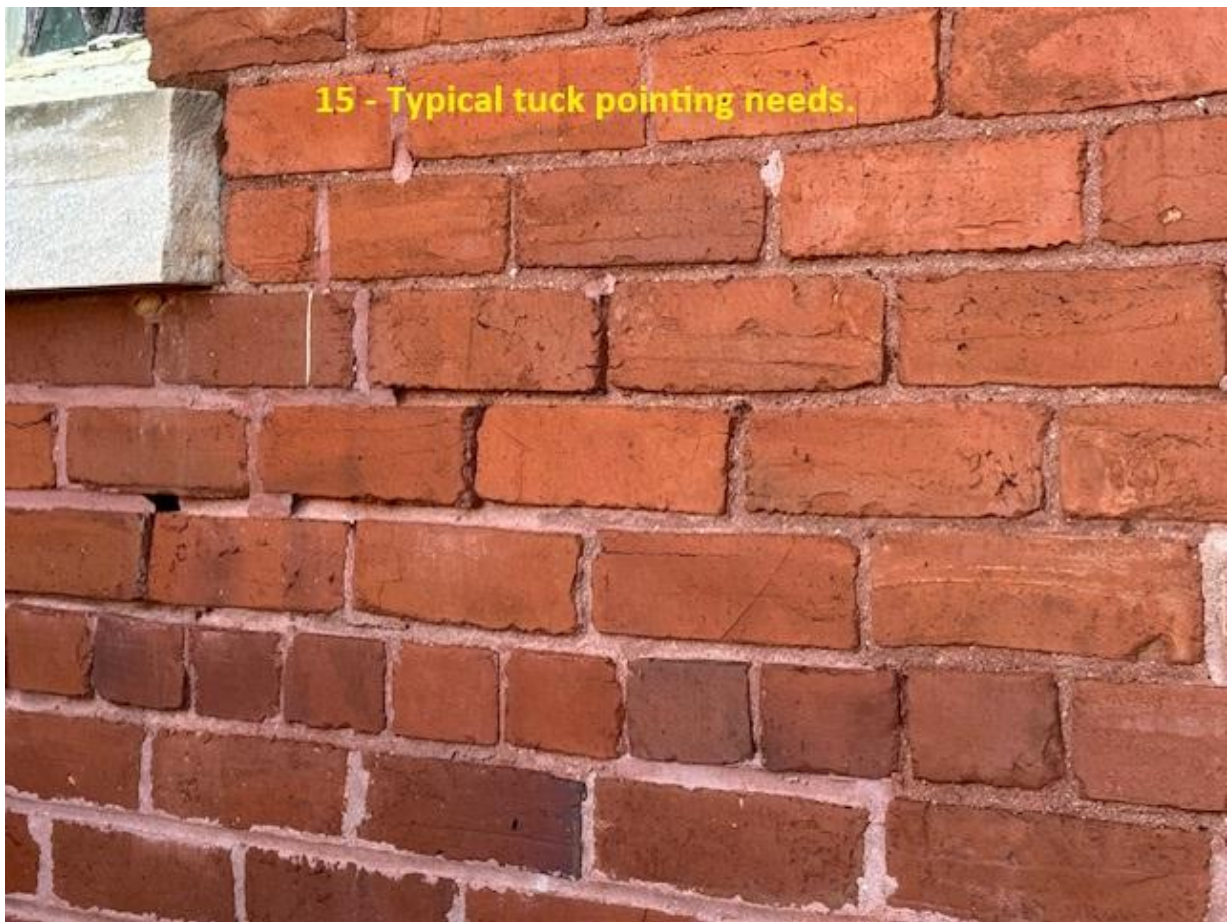
15 - Typical tuck pointing needs.

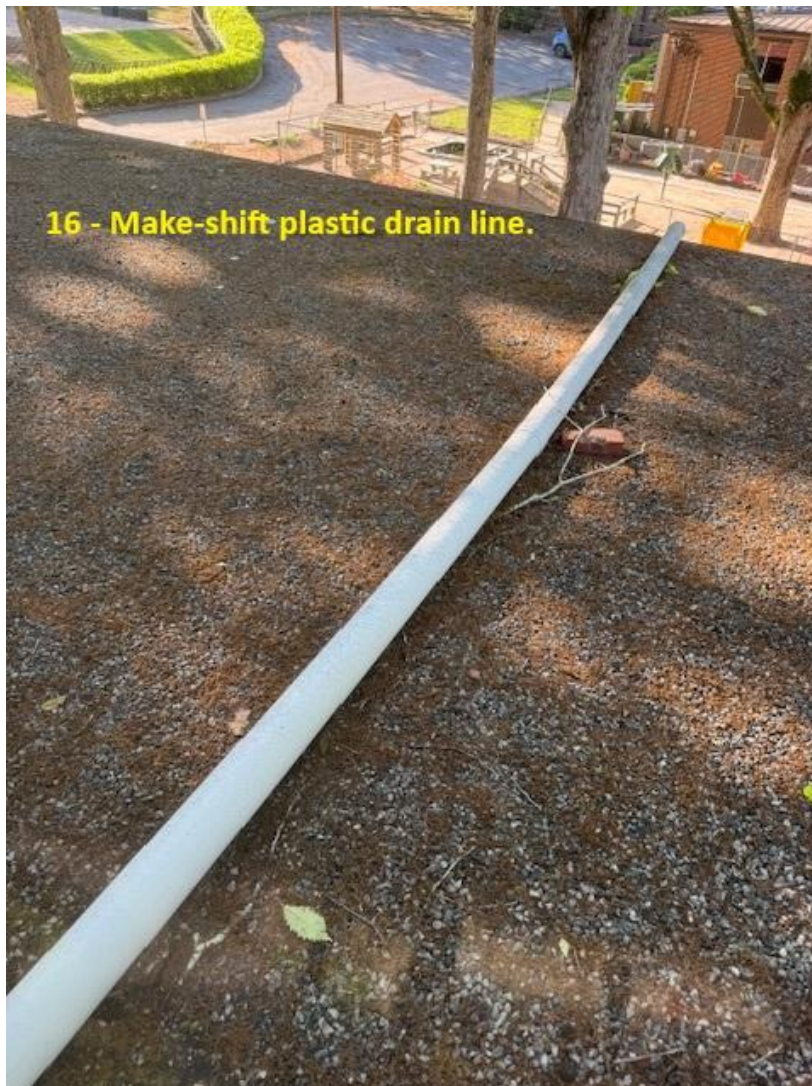
16 - Make-shift plastic drain line.

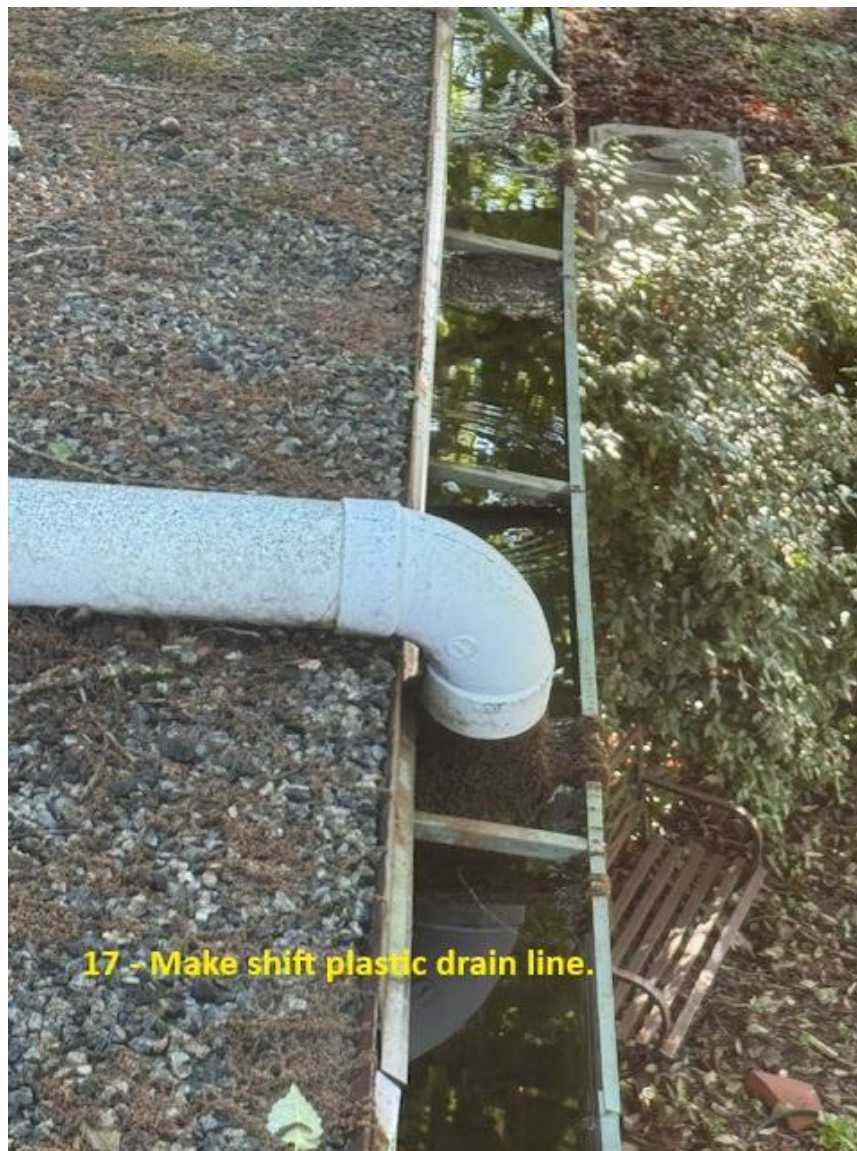
17 - Make shift plastic drain line.

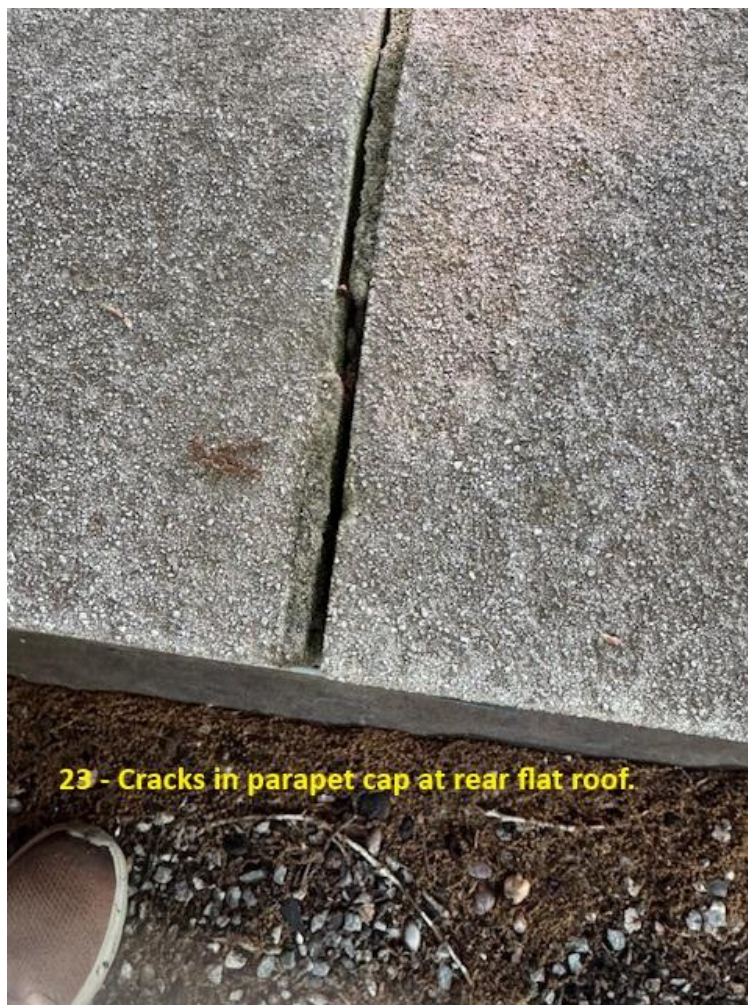
23 - Cracks in parapet cap at rear flat roof.

- Fabricate and install new 160z. copper copings at all parapet wall conditions.
    - This application along with the TPO roof membrane will bury the disintegrating joints of the existing stone parapets.

- See photos 21 and 23 through 25.
  - Fabricate and install new 160z. counter flashing inserted into cut in masonry wall at roof/wall intersection.

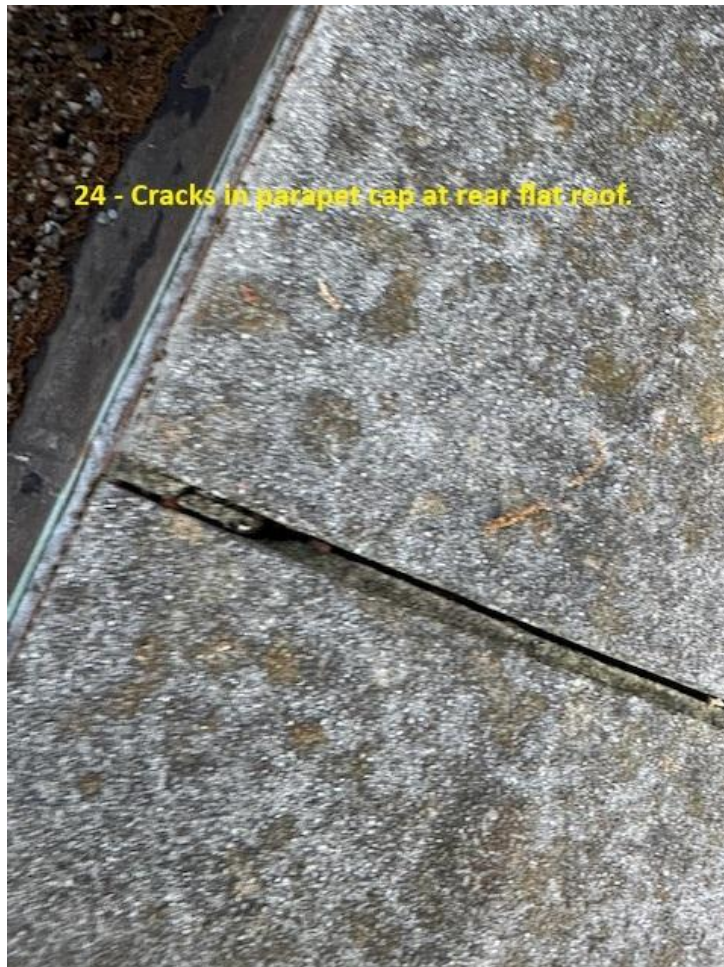
24 - Cracks in parapet cap at rear flat roof.

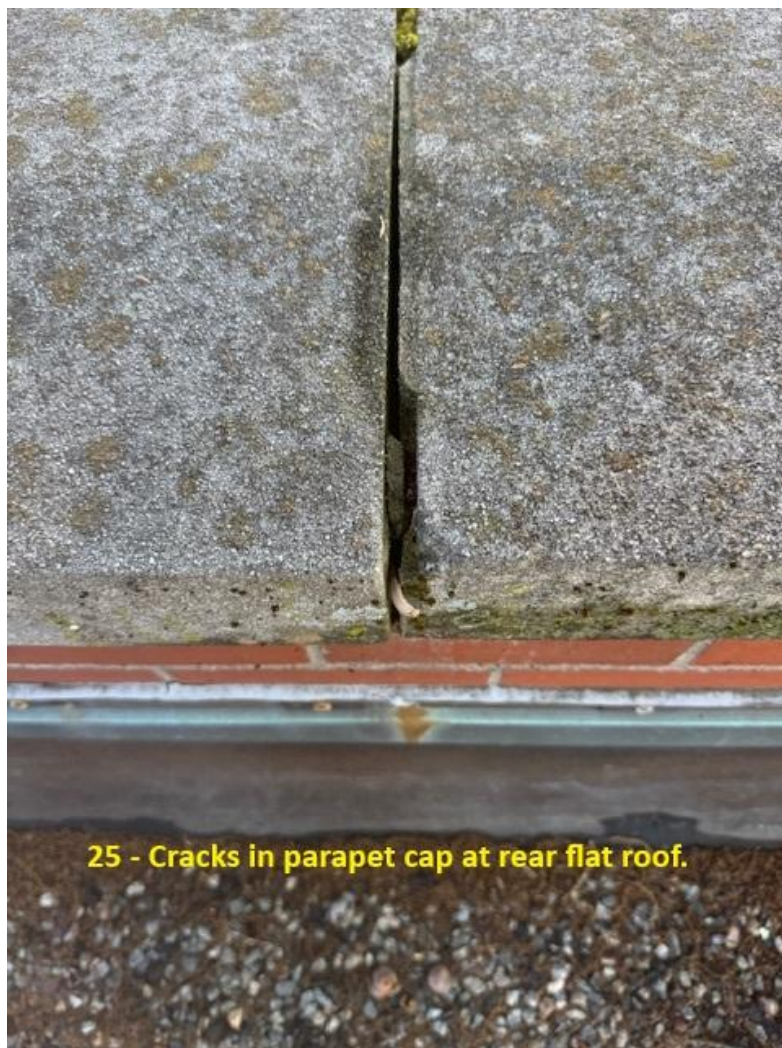
25 - Cracks in parapet cap at rear flat roof.

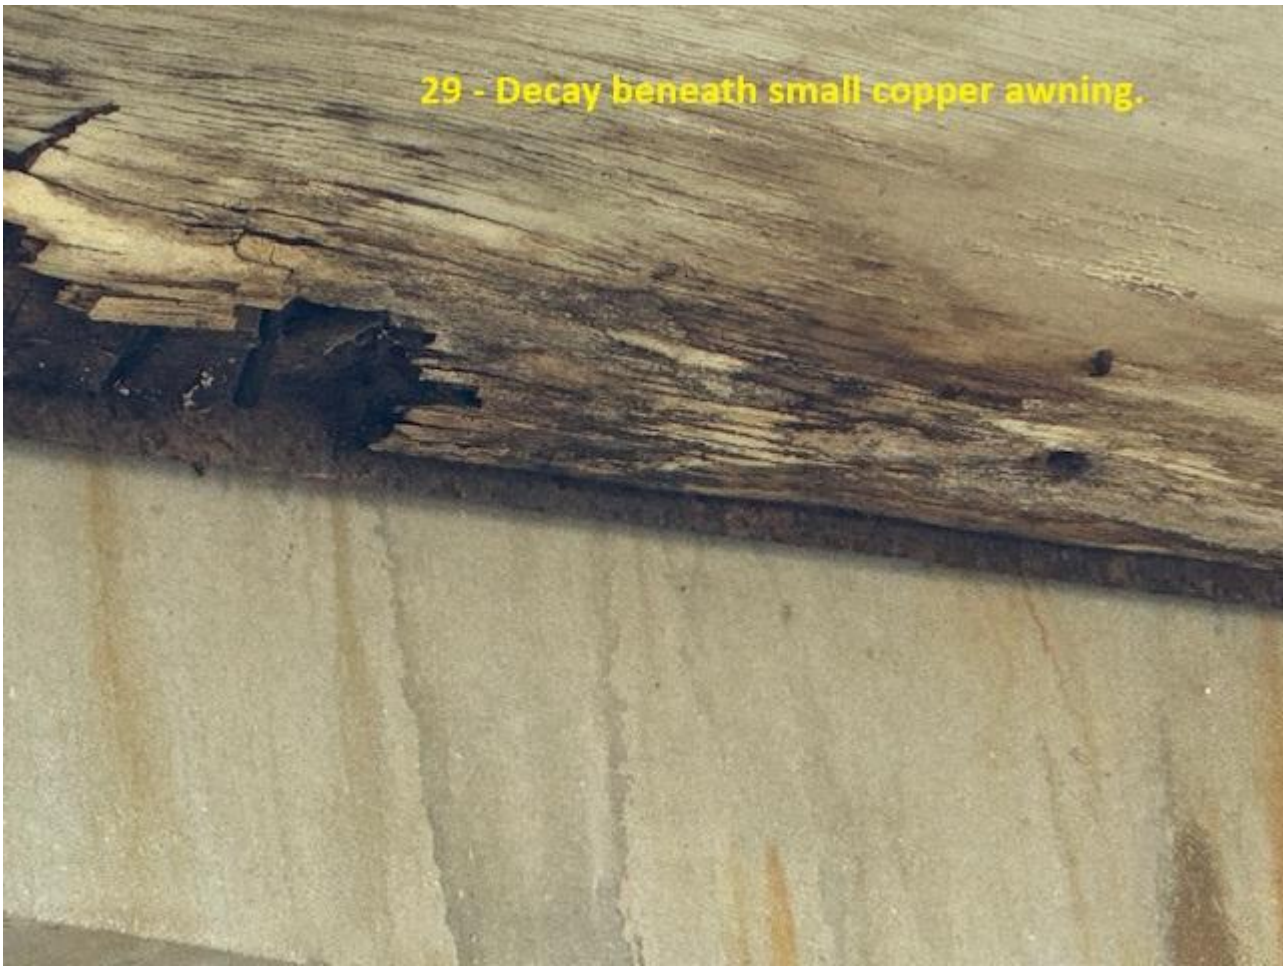
29 - Decay beneath small copper awning.

- See photo 27 and 29.
  - Replace deteriorated structural wood beneath left copper awning.
    - See photo 27.
  - Completely rebuild, as required, all structural wood beneath right small copper awning (extensive).

- See photo 29.
    - Photo 31 represents the damage below the right small copper awning.
  - Install new ceilings at each awning and paint each ceiling using Sherwin Williams exterior enamel paint.

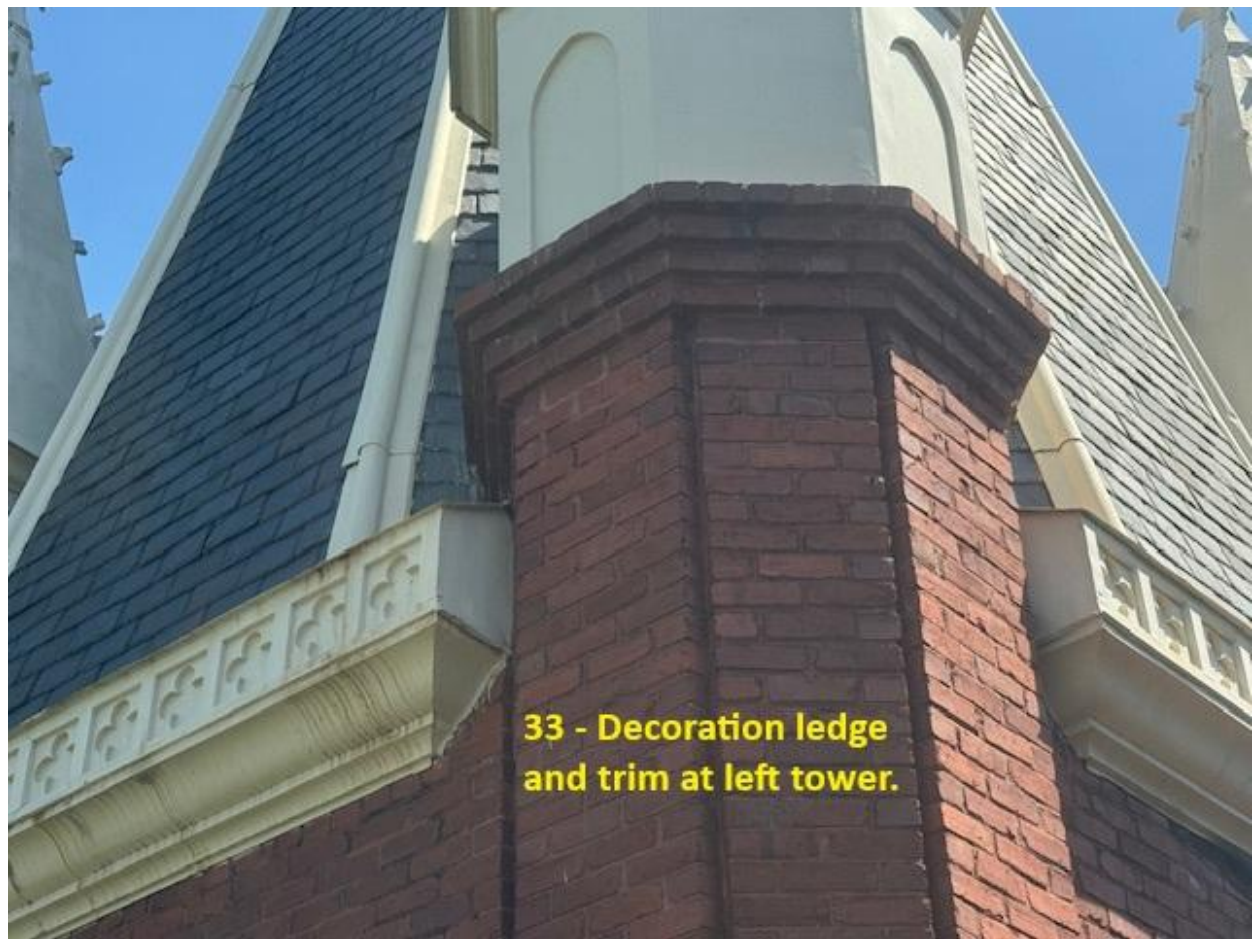
**32 - Decoration ledge and trim at left tower.**

- Towers
  - Provide all manlifts and/or scaffolding to perform work at this area.
  - Provide lawn repairs, as needed, to areas damaged by equipment.
  - Rebuild upper portions of ledges at each tower using stainless steel and/or copper and/or various sealants and membranes.

- See photos 32, 33, and 36.
  - Perform brick repair to void beneath crown molding at left tower.
    - See photo 35.
  - Replace all rotten lumber in louvered areas on both towers

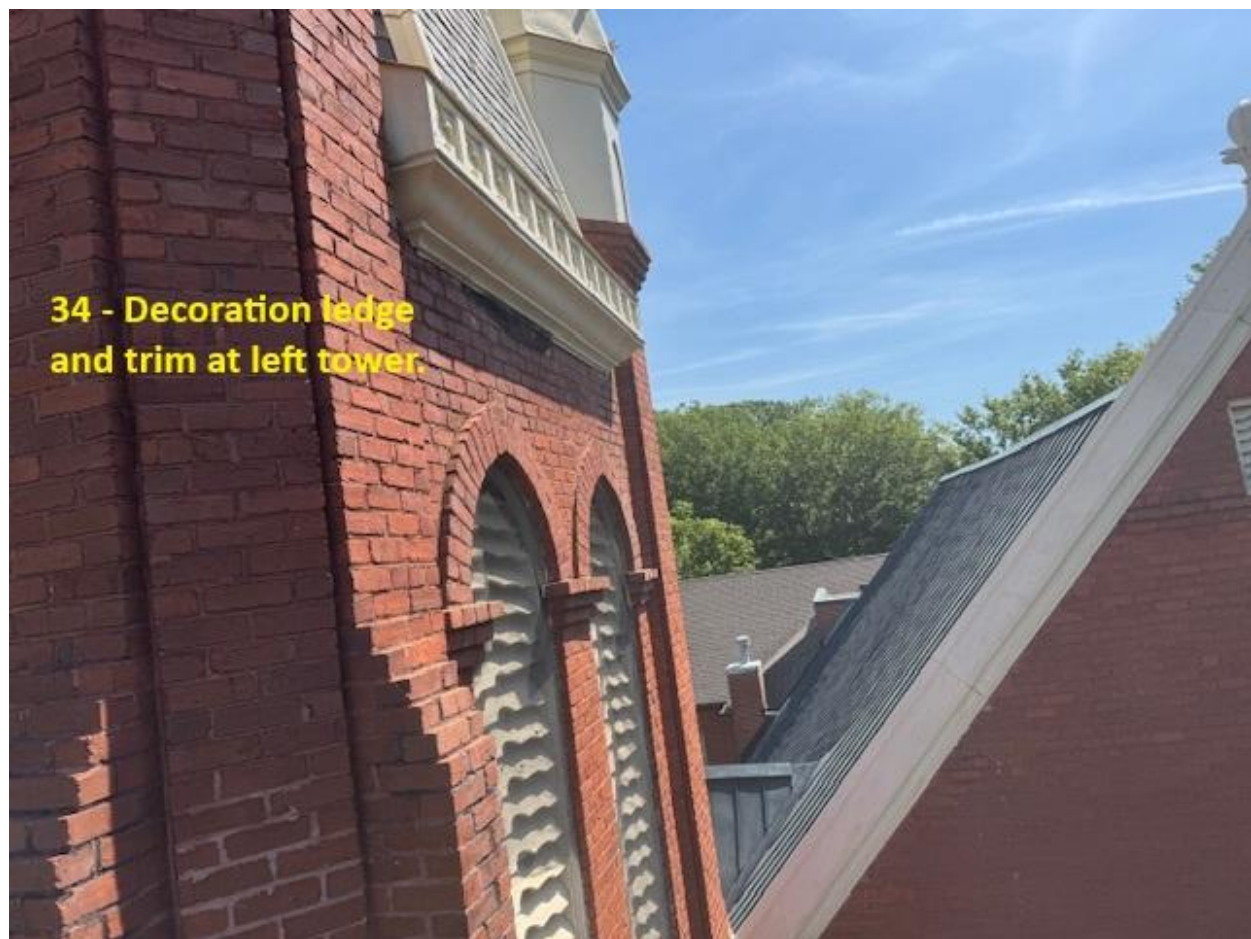
**33 - Decoration ledge  
and trim at left tower.**

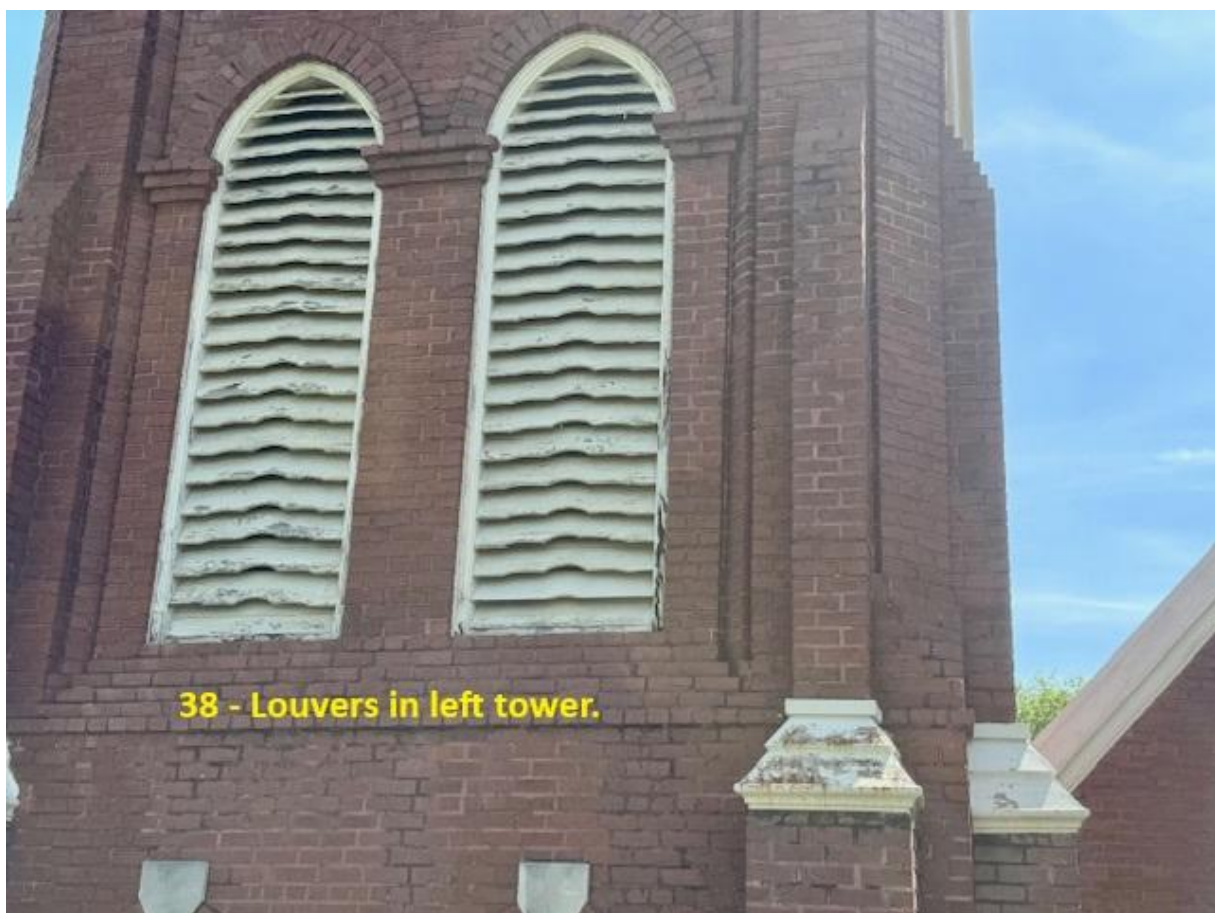
37 - Louvers in left tower.

- See photos 37 and 38
  - Fabricate and install non-existent counter flashings at ornamental column covers.
    - See photo 39.
  - Thoroughly clean, wire brush, sand, and/or grind all ledges, column covers, and louvers at both towers.

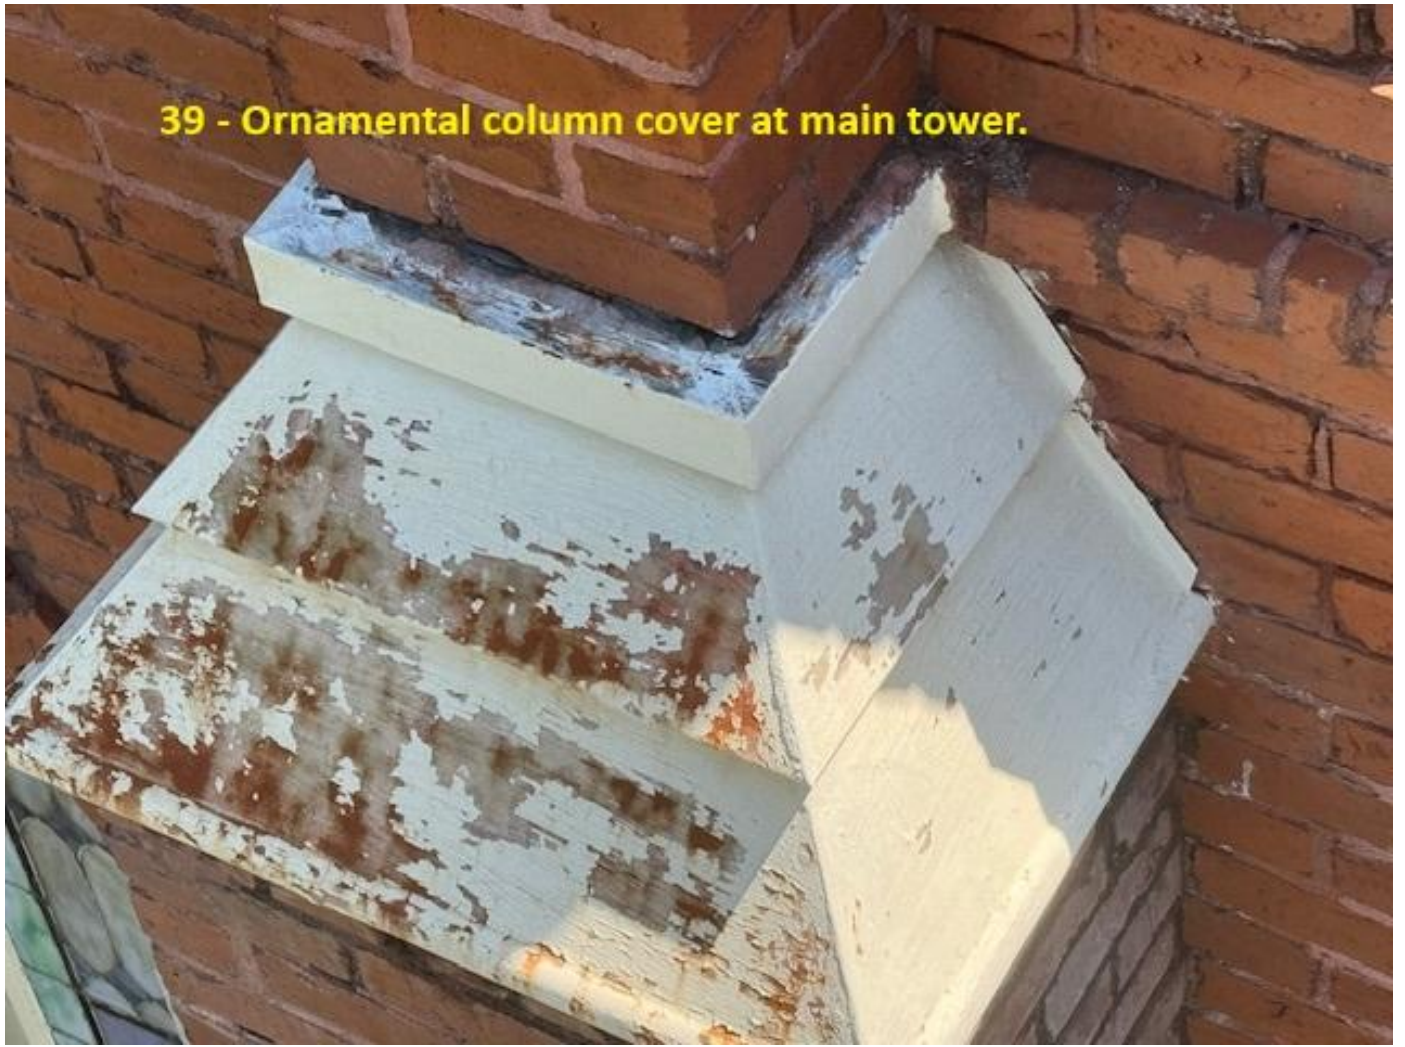
**39 - Ornamental column cover at main tower.**
