# Conceptual Estimate

## First Presbyterian Church Exterior Envelope Renovation

**May 8, 2025**

**Garbutt Construction**

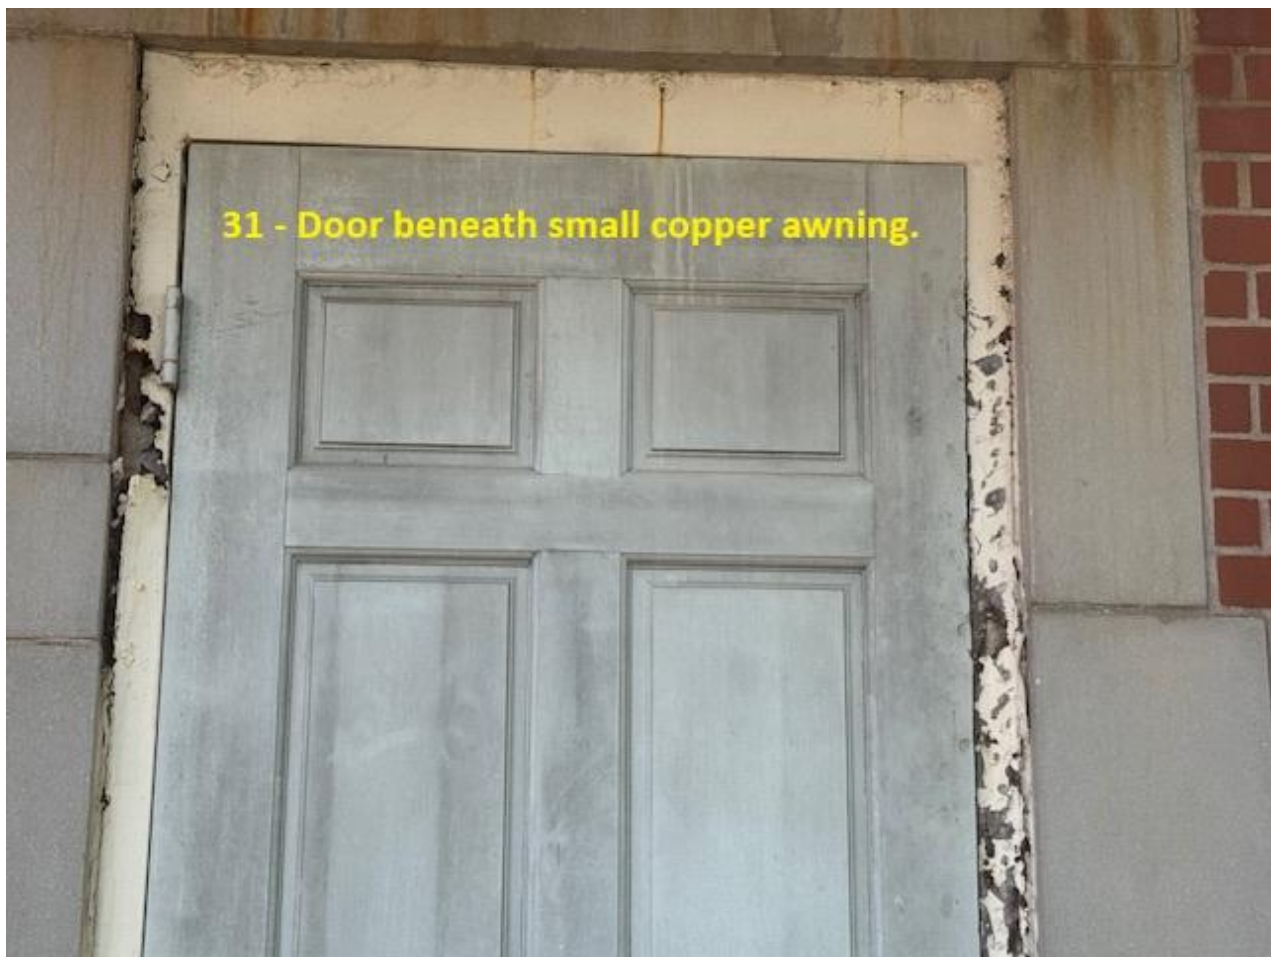
**31 - Door beneath small copper awning.**

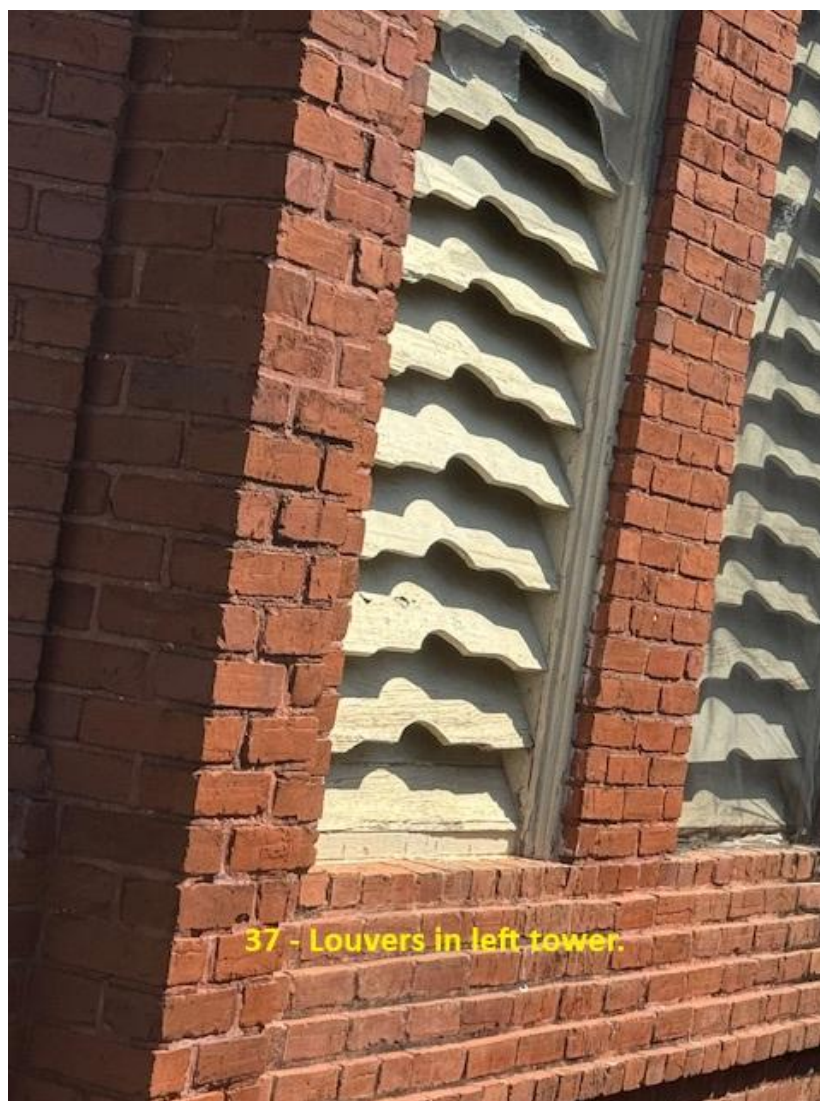
37 - Louvers in left tower.

- See photos 32, 33, and 36.
  - Perform brick repair to void beneath crown molding at left tower.
    - See photo 35.
  - Replace all rotten lumber in louvered areas on both towers
